NACA RM E53G07

INVESTIGATION OF A CHROMIUM PLUS ALUMINUM OXIDE METAL-CERAMIC BODY FOR POSSIBLE GAS TURBINE BLADE APPLICATION

By Charles A. Hoffman

Lewis Flight Propulsion Laboratory
Cleveland, Ohio

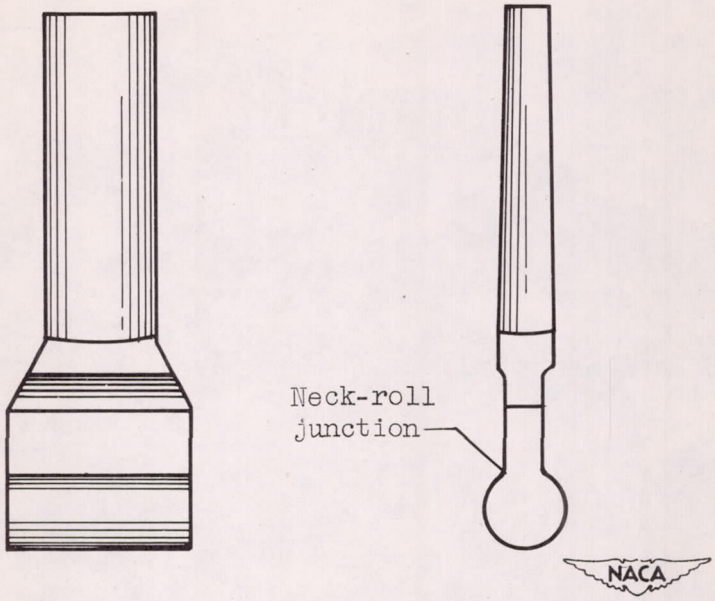
Figure 1. - Cermet blade.

chromium, and 0.14 percent iron, by weight. The modulus-of-rupture bars were 1/2 by 1/4 by 4 inches; the thermal-shock disks were 1/2 inch thick by 2 inches in diameter. The blade is illustrated in figure 1 and is identical in design to that used in previous investigations (refs. 2 and 3).

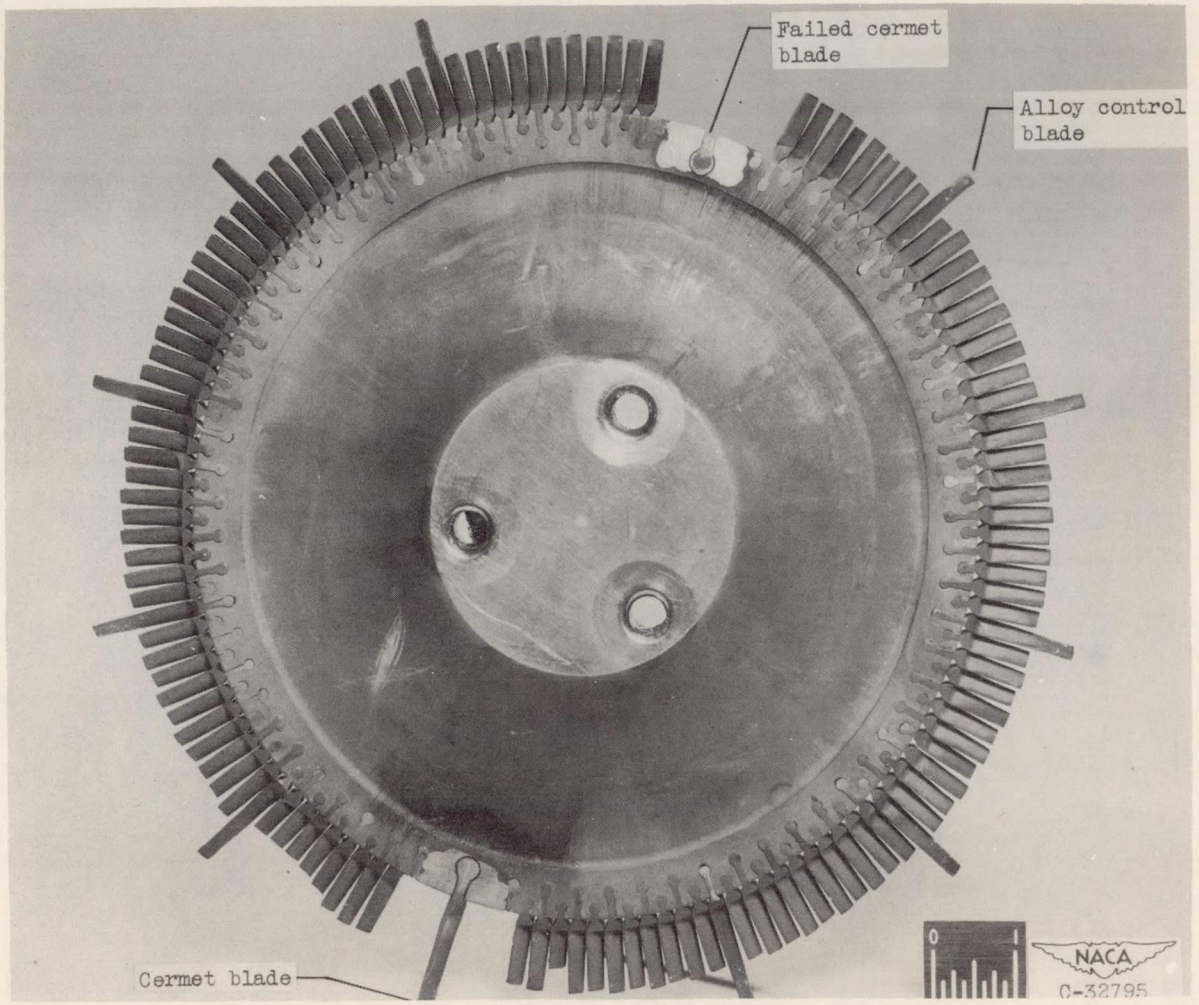
All the blades failed in the range of 18,000 to 20,000 rpm during the approach to 22,850 rpm, and at a blade temperature of about 1450° F. The total time of operation was less than 5 minutes in each case. There were no metal blade failures. All the failures occurred in the base at the neck-roll junction. The wheel containing a failed Cr + Al_2O_3 blade is shown in figure 2. A more detailed view of a failed blade is shown in figure 4.

Figure 2. - Wheel after failure of a cermet blade.

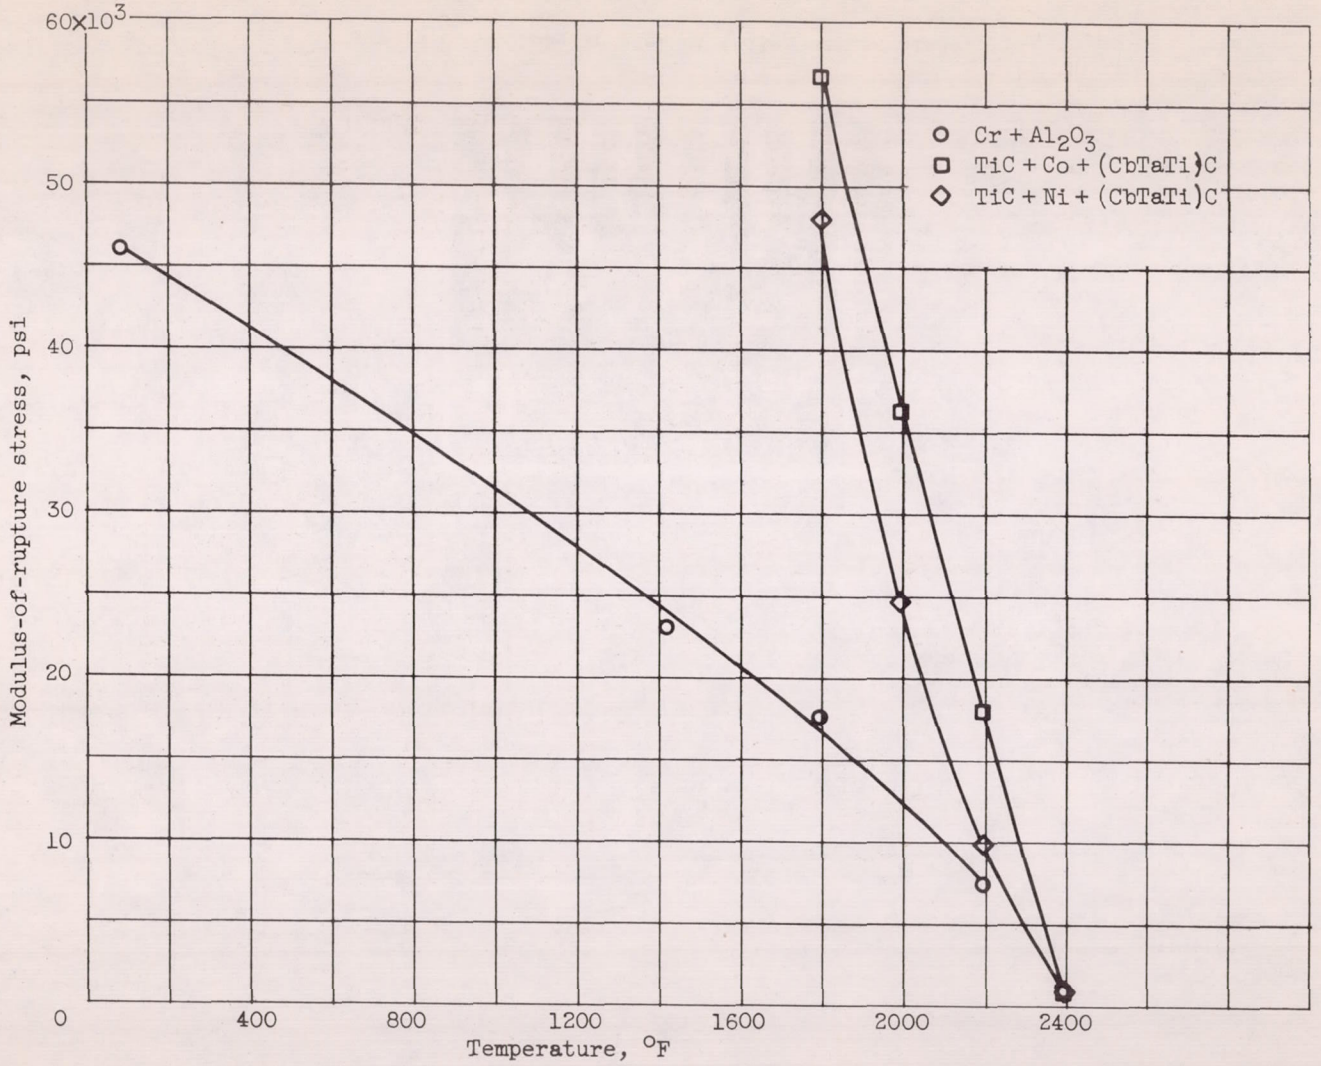
Figure 3. - Modulus-of-rupture stress against temperature. ($Cr + Al_2O_3$ specimens had 2-in. span; TiC specimens had 3.5-in. span. All were tested in argon atmosphere.)

The modulus-of-rupture results are shown in table II(a) and presented graphically in figure 3. These values may be compared (fig. 3) with those for 65 percent TiC + 20 percent Co + 15 percent (CbTaTi)C (table II(b) and ref. 2), two cermets that have been intensively studied; it is seen that the 80 percent Cr + 20 percent Al_2O_3 has poorer modulus-of-rupture strength. However, for a complete comparison it would be necessary to obtain relative strengths based on the long-time stress-rupture properties.

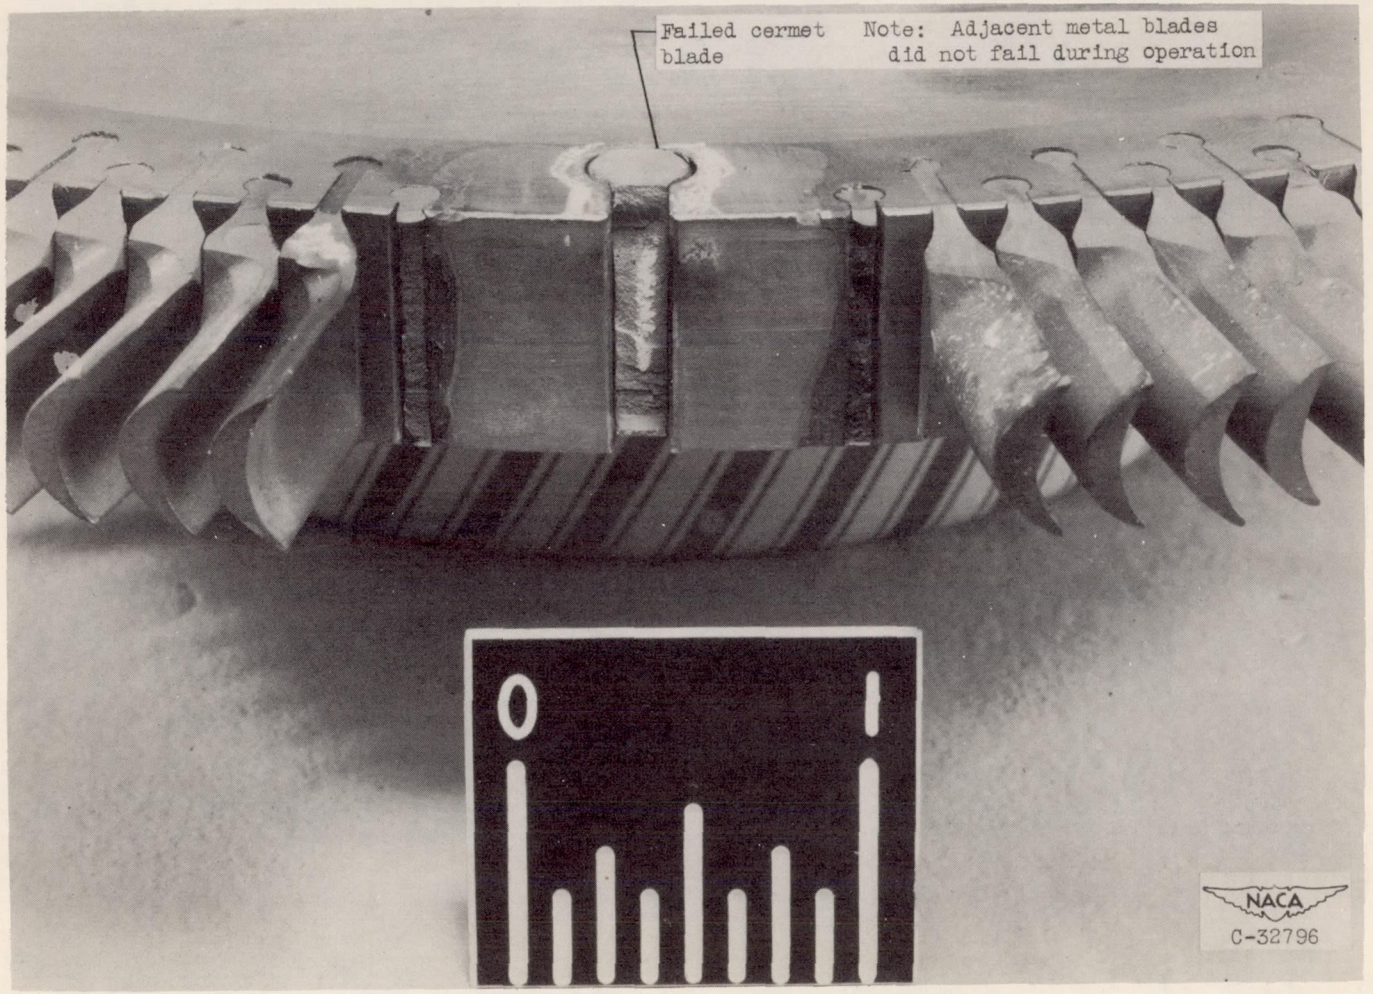
The failures did not appear to originate from the surface flaws noted during the preoperation inspection, and a study of the failure cross sections failed to reveal any internal flaws which may have caused the failures. The failures occurred in a short time and may be associated with the short-time strength of the material. The temperature at the failure zone was estimated to be 1200° F. The stress at the failure zone, at the time of failure and without considering stress-concentration factors, was approximately 12,000 pounds per square inch. From figure 3, the modulus-of-rupture strength is 26,000 pounds per square inch, at 1200° F. Assuming the tensile strength to be about one half the modulus-of-rupture strength (this assumption is widely accepted as valid for brittle materials), the maximum allowable stress in the root is 13,000 pounds per square inch. Hence, on this basis it appears that the material was operating very near its ultimate tensile strength.

Figure 4. - Close-up view of failed cermet blade.
